EFFECT OF SULFUR IN JP-5 FUEL ON HOT CORROSION OF COATED SUPERALLOYS IN MARINE ENVIRONMENT

FINAL SUMMARY REPORT
APRIL 1, 1967 TO MARCH 31, 1968

BY
H. T. QUIGG AND R. M. SCHIRMER

PHILLIPS PETROLEUM COMPANY - RESEARCH DIVISION REPORT 5058-68R

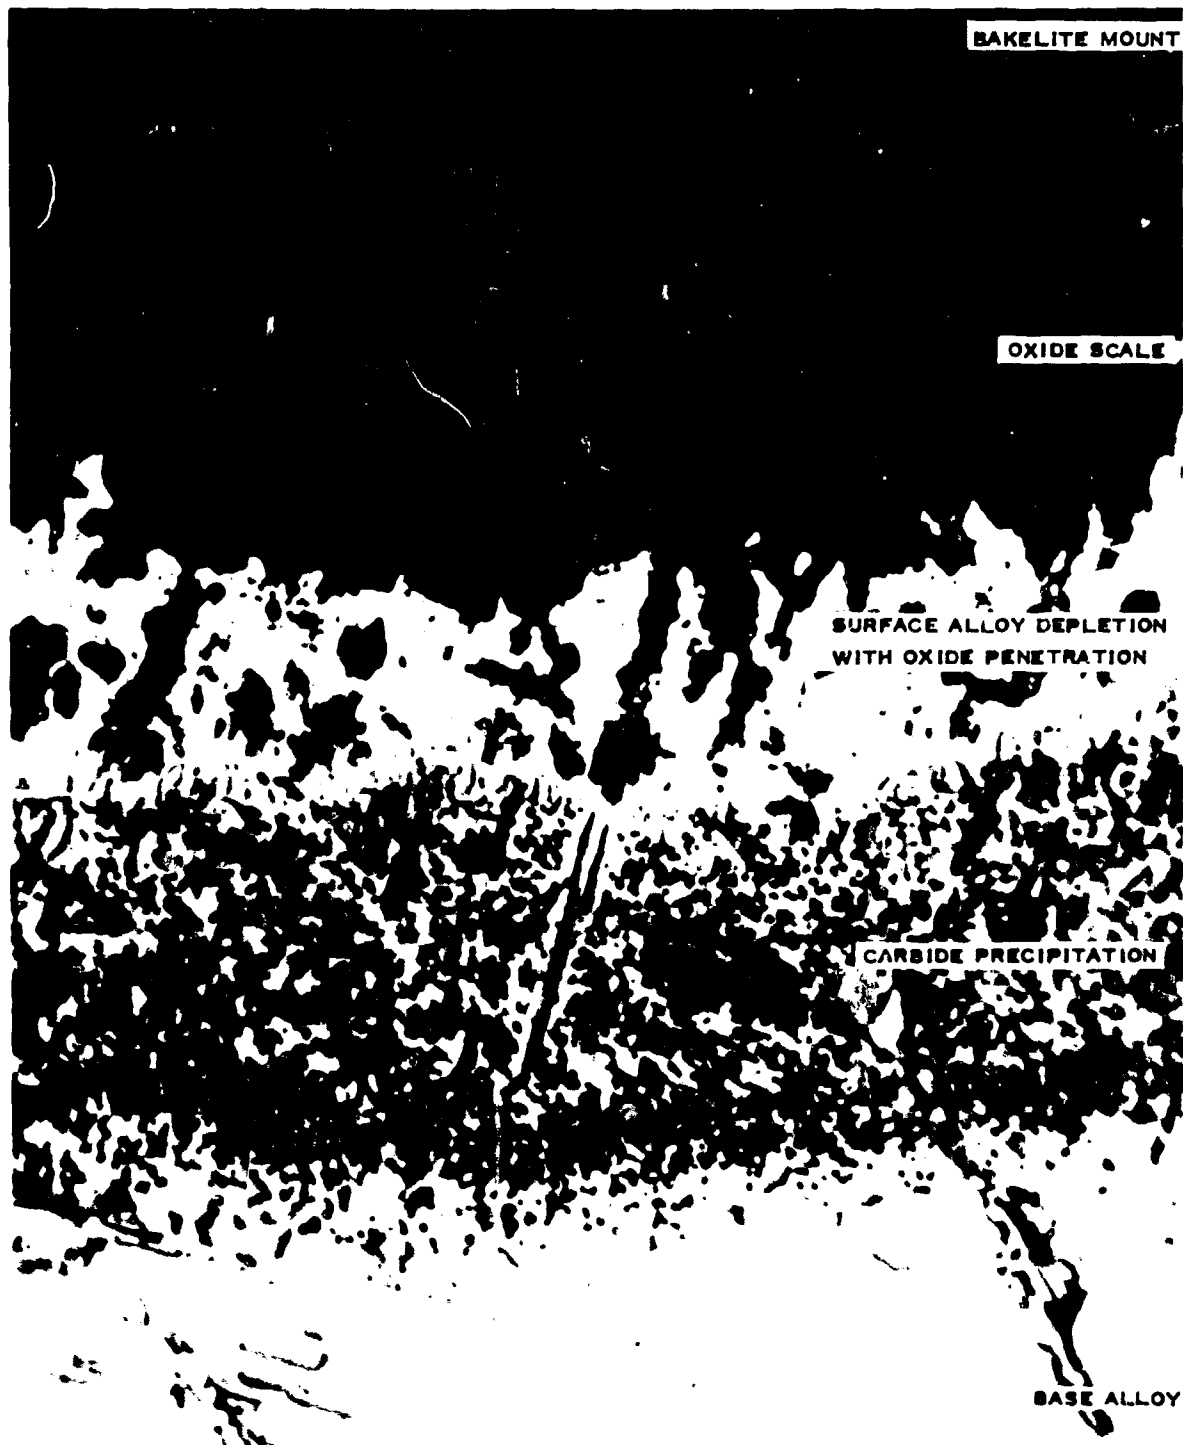
FIGURE 1
OXIDATION OF UHMET 500 TURBINE BLADE

METALLOGRAPHIC CROSS-SECTION. MARBLE'S REAGENT ETCHED. 2000X MAGNIFICATION.

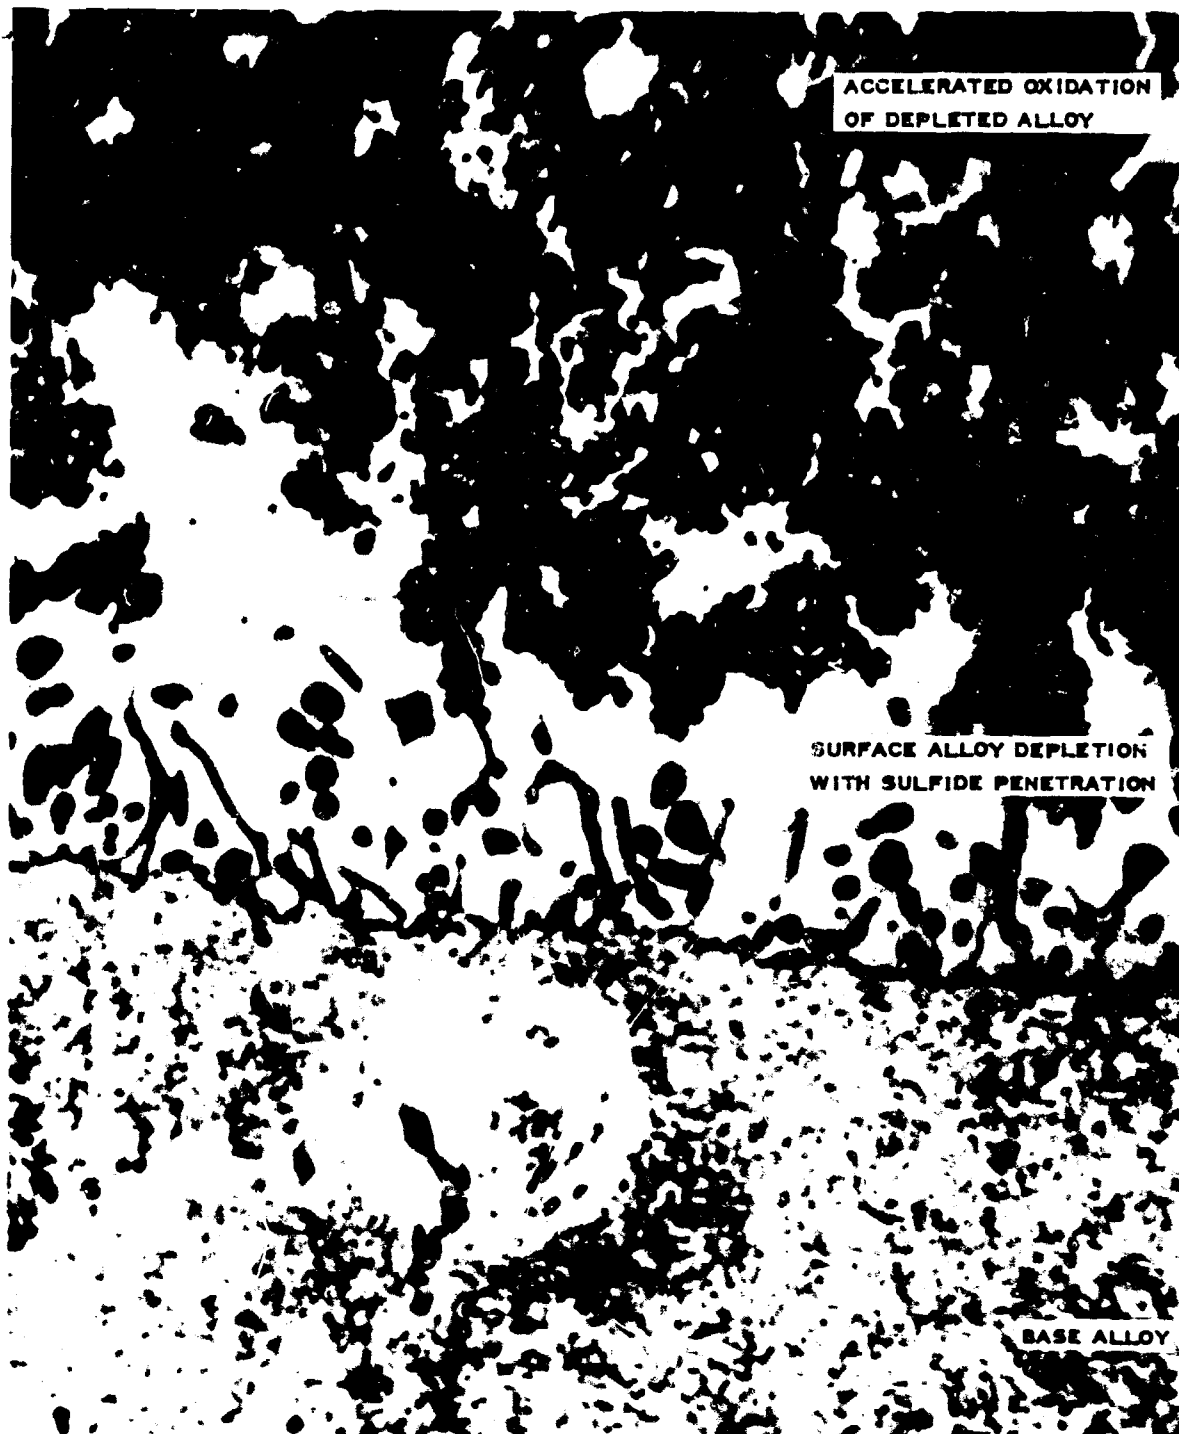
FIGURE 2
ACCELERATED OXIDATION OF INCONEL 713C TURBINE BLADE

METALLOGRAPHIC CROSS-SECTION. MARBLE'S REAGENT ETCHED. 4000X MAGNIFICATION.

The accelerated attack on aviation-turbine engines when operated in a marine environment is shown in Figure 2. This photomicrograph was taken at the leading edge of a cross-section from the center of a first-stage turbine blade recovered from a scrap drum at a U.S. Navy engine-overhaul shop. Deep sub-surface oxidation produced a mixed-phase zone composed of metal and corrosion products; however, considerable metal loss can be sustained without blade failure because the attack advances on a broad front without deep-intercrystalline penetration of sulfides or oxides. The attack is led by penetration of randomly dispersed, light-grey globules of metallic sulfides. Formation of these sulfides is associated with changes in the surface composition of the alloy, which is characterized by chromium depletion. The mechanism of hot corrosion is complex and not fully understood.

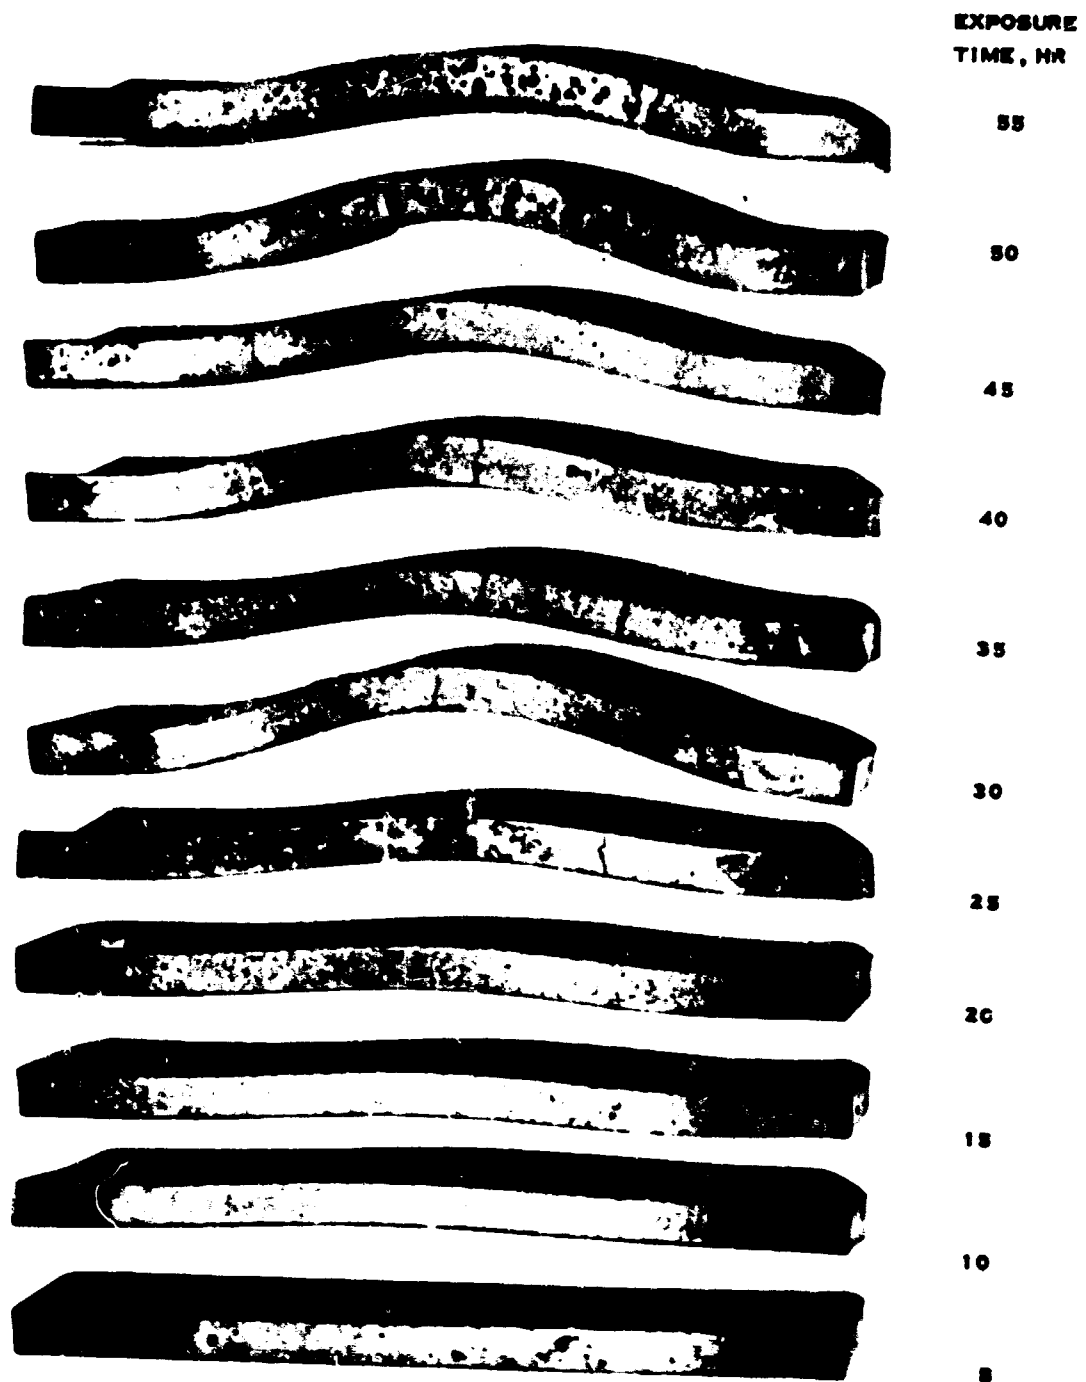
FIGURE 8
DEVELOPMENT OF CRACKS IN LEADING EDGE
OF MISCO MDC-9 COATED INCONEL 713C SPECIMENS

2X MAGNIFICATION OF SONICALLY-CLEANED SPECIMENS
AFTER EXPOSURE AT 2000 F TEST CONDITION
WITH NO SEA SALT IN AIR AND 0.040 WT % SULFUR IN FUEL

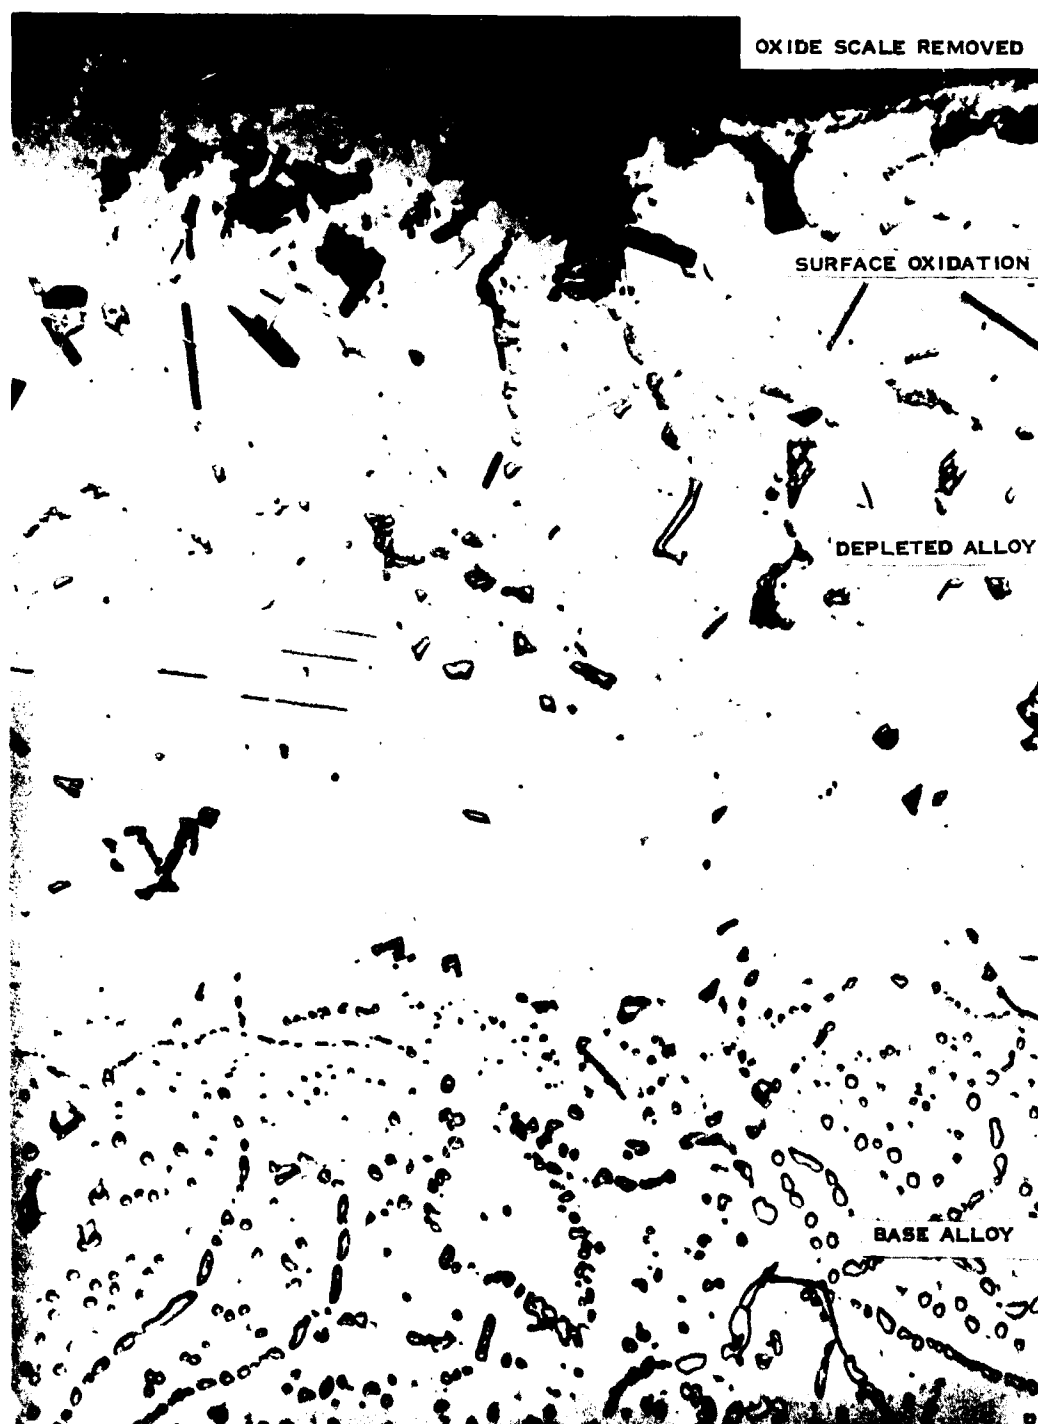
FIGURE 10
SURFACE OXIDATION

METALLOGRAPHIC CROSS-SECTION OF INCONEL 713C SPECIMEN AFTER 55 HOURS AT 2000F TEST CONDITION.
ELECTRO-CLEANED. MARBLE'S REAGENT ETCHED. 1000X MAGNIFICATION.

Exposure of Inconel 713C with sea salt in the environment, but free of vanadium, at the 2000 F condition produced an accelerated-oxidation attack. In general, the attack advanced on a broad front without deep-intercrystalline penetration of the corrosive agents and was led by penetration of randomly-dispersed, light-grey globules of metallic sulfides. The formation of these sulfides was associated with changes in the surface composition of the alloy, which is characterized by chromium depletion. Rapid oxidation of the weakened alloy follows (Figure 11). The depth of the zone of alloy depletion was less than 0.4 mil, which is in sharp contrast to the order of magnitude greater depth shown in Figure 10 with simple surface oxidation.

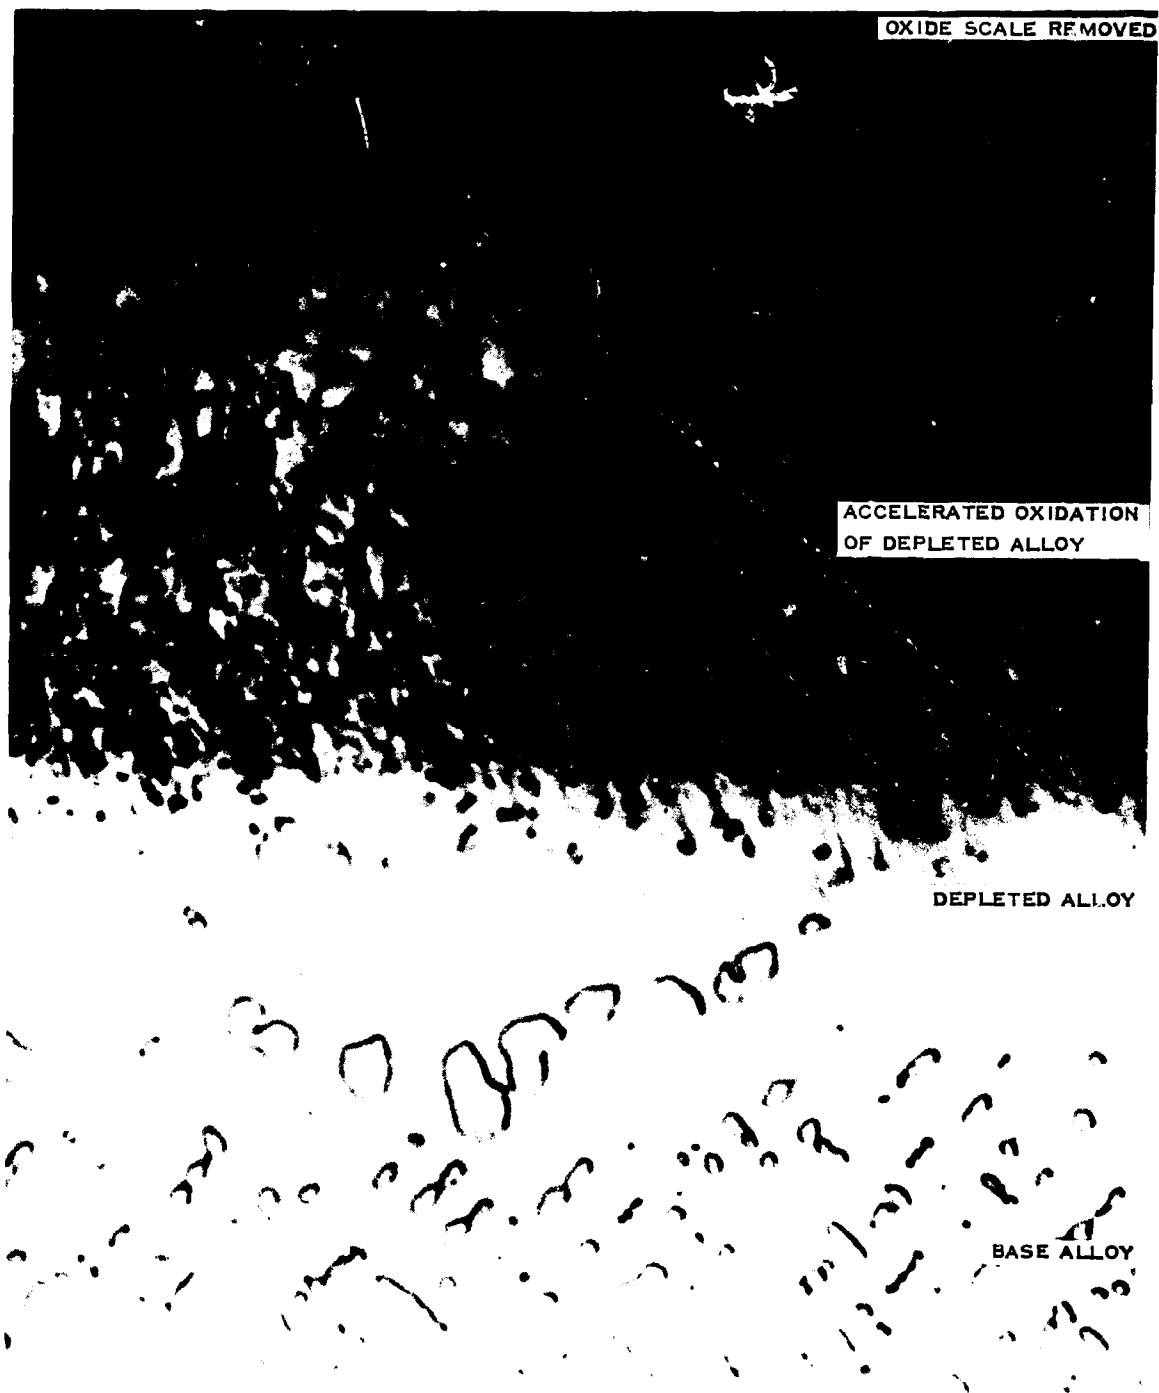
FIGURE 11
ACCELERATED SURFACE OXIDATION

METALLOGRAPHIC CROSS-SECTION OF INCONEL 713C SPECIMEN AFTER 25 HOURS AT 2000F TEST CONDITION WITH 1.0 PPM SEA SALT IN AIR. ELECTRO-CLEANED. CARPELLA'S REAGENT ETCHIED. 4000X MAGNIFICATION.

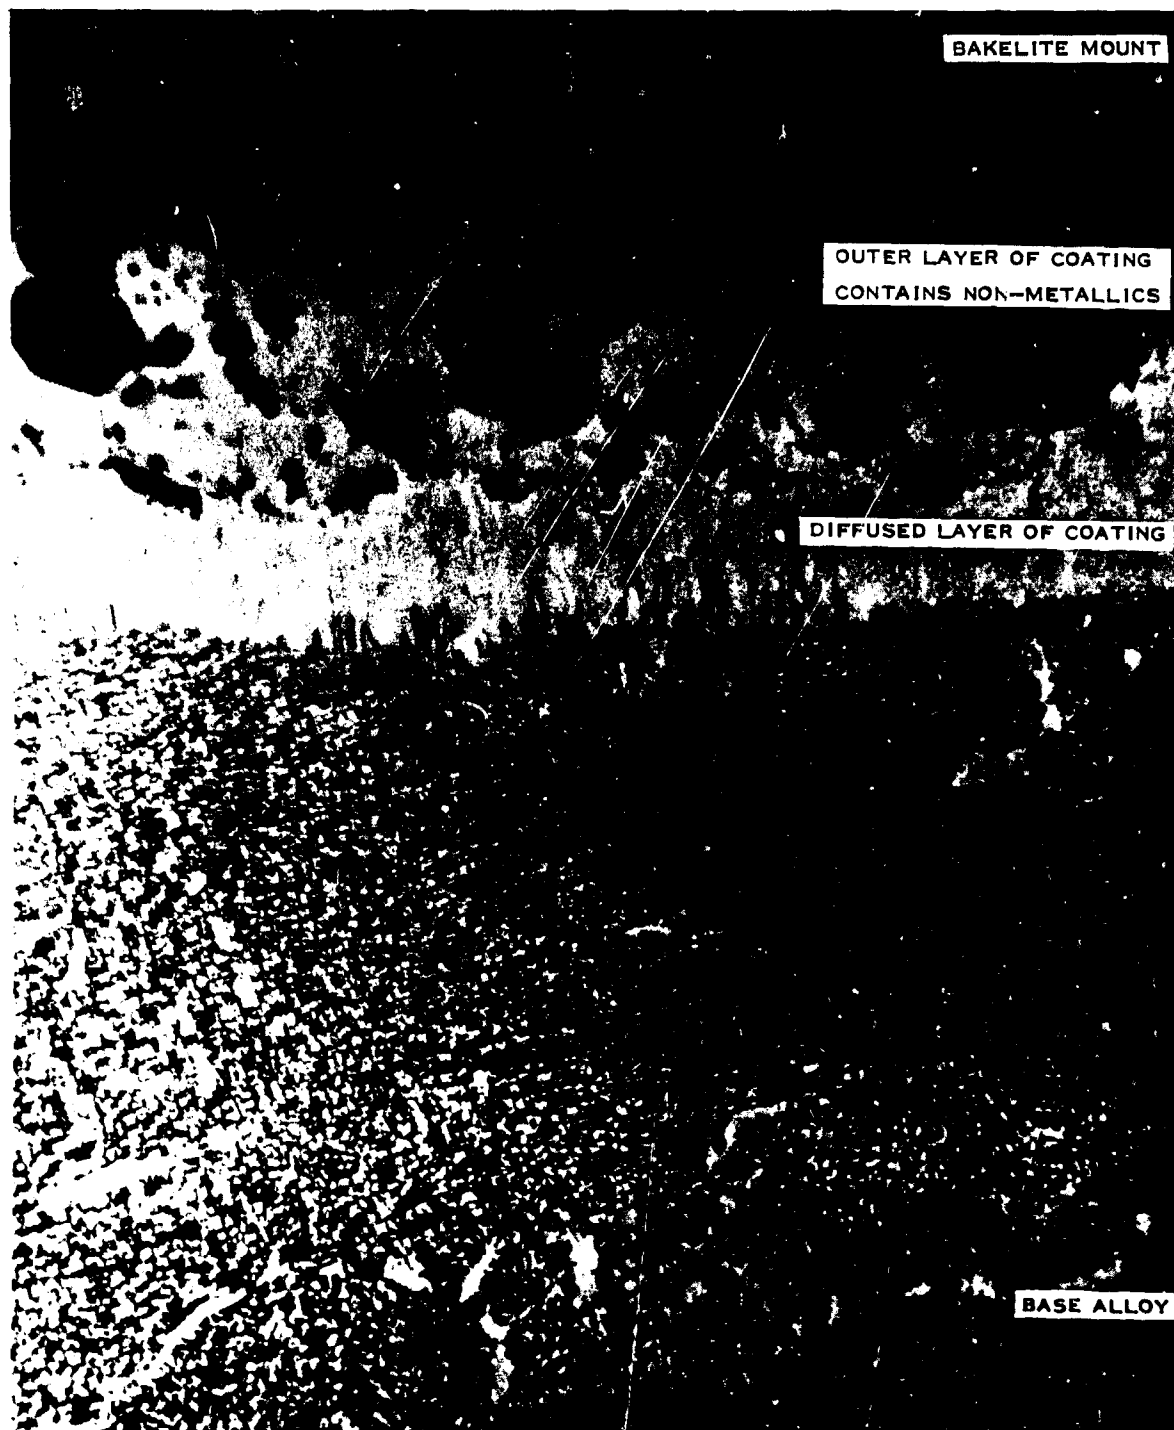
FIGURE 12
UNEXPOSED MISCO MDC-1 COATED INCONEL 713C SPECIMEN

METALLOGRAPHIC CROSS-SECTION, 3% SULFURIC ACID-ELECTROLYTIC ETCHED,
1000X MAGNIFICATION.

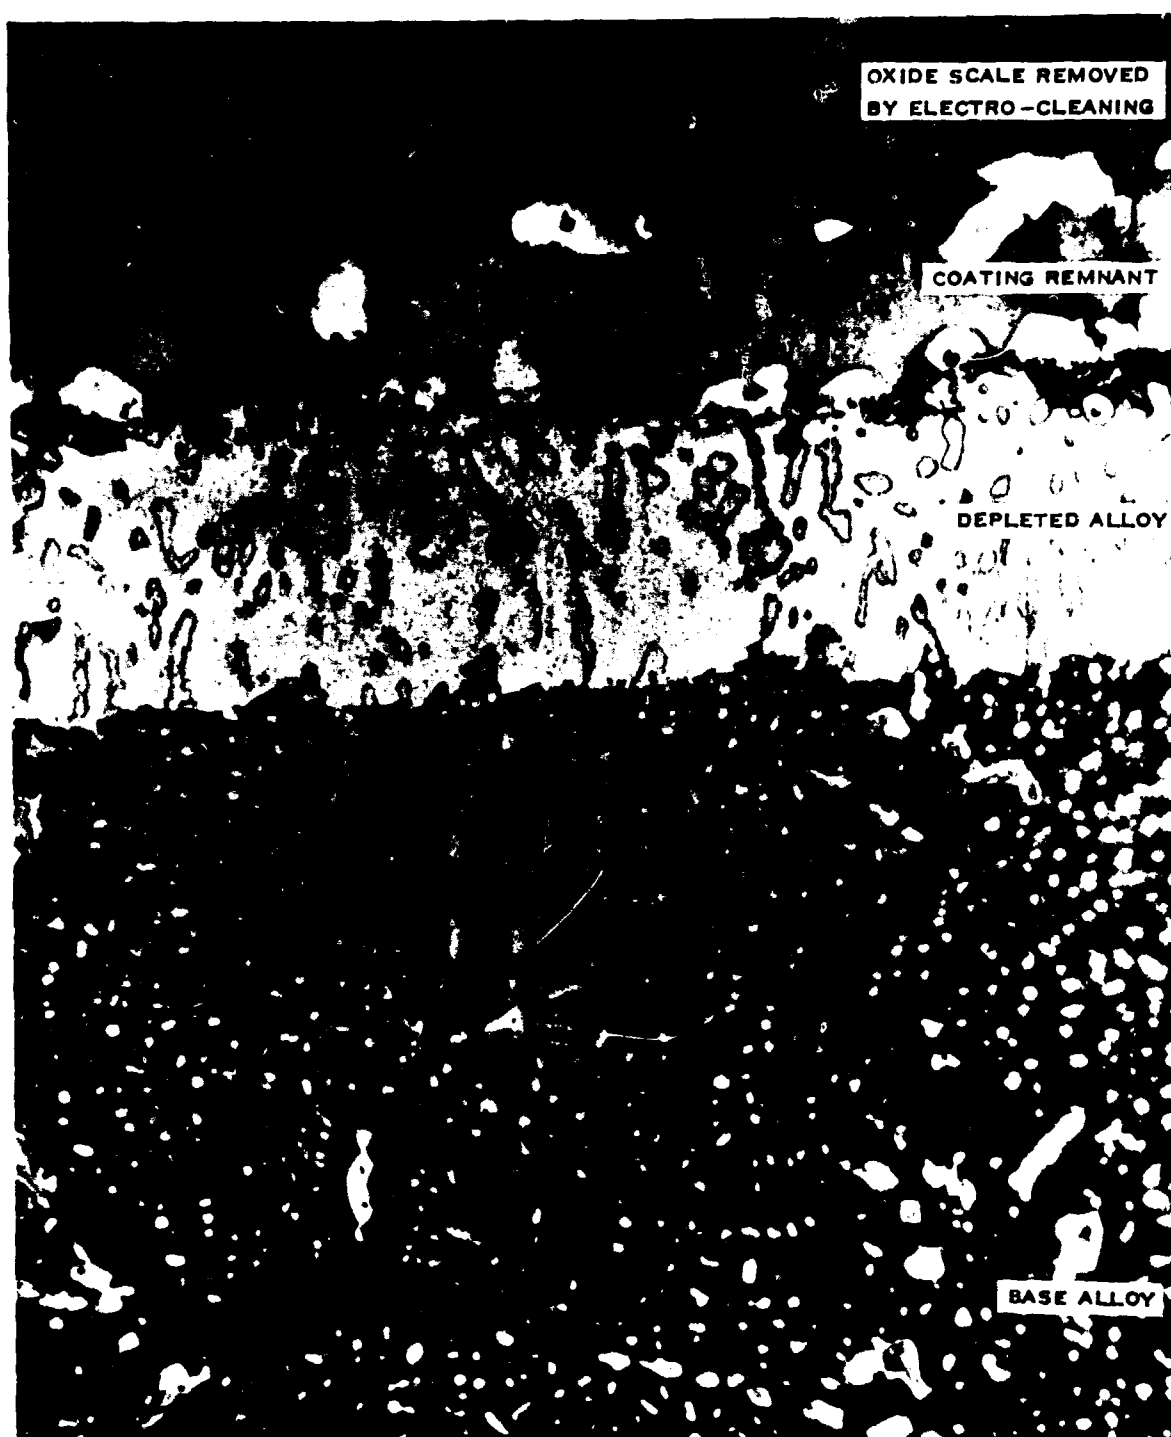
FIGURE 13
DEPLETION OF MISCO MDC-1 COATED INCONEL 713C SPECIMEN

METALLOGRAPHIC CROSS-SECTION OF SPECIMEN AFTER 20 HOURS AT 2000 F TEST
CONDITION WITH 1.0 PPM SEA SALT IN AIR AND 0.040 WT % SULFUR IN FUEL.
2% CHROMIC ACID-ELECTROLYTIC ETCHED. 1000X MAGNIFICATION.

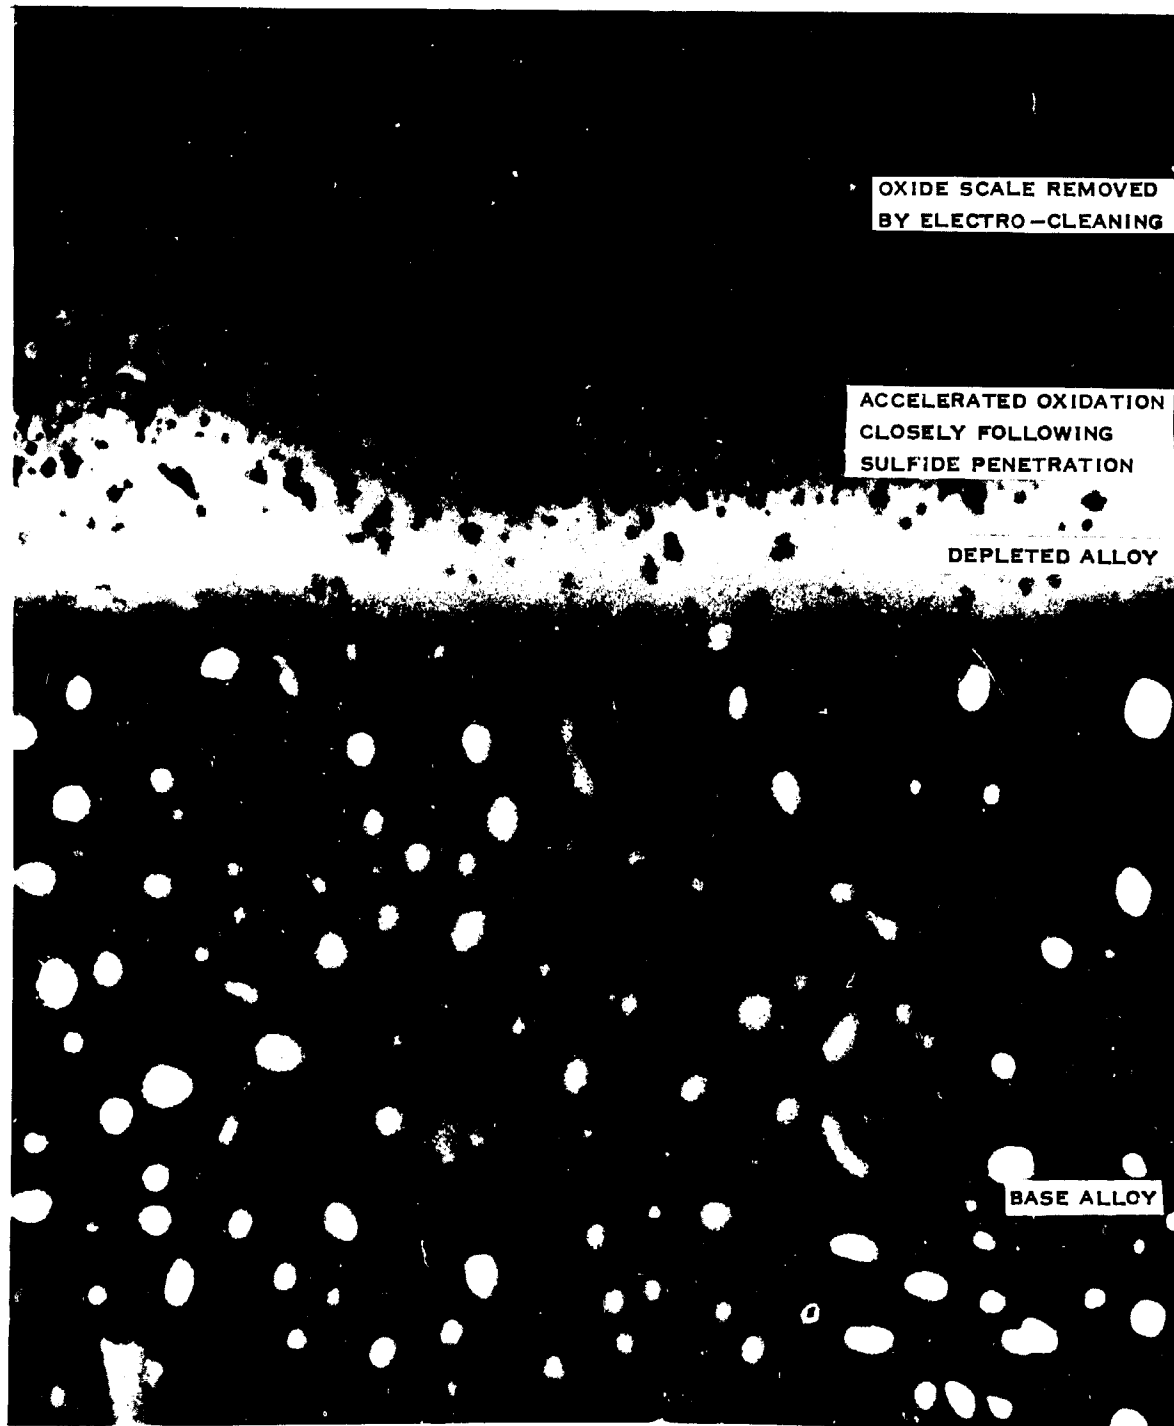
FIGURE 14
ACCELERATED OXIDATION OF MISCO MDC-1 COATED INCONEL 713C SPECIMEN

METALLOGRAPHIC CROSS-SECTION OF SPECIMEN AFTER 20 HOURS AT 2000 F TEST
CONDITION WITH 1.0 PPM SEA SALT IN AIR AND 0.040 WT % SULFUR IN FUEL,
2% CHROMIC ACID-ELECTROLYTIC ETCHED. 3000X MAGNIFICATION.

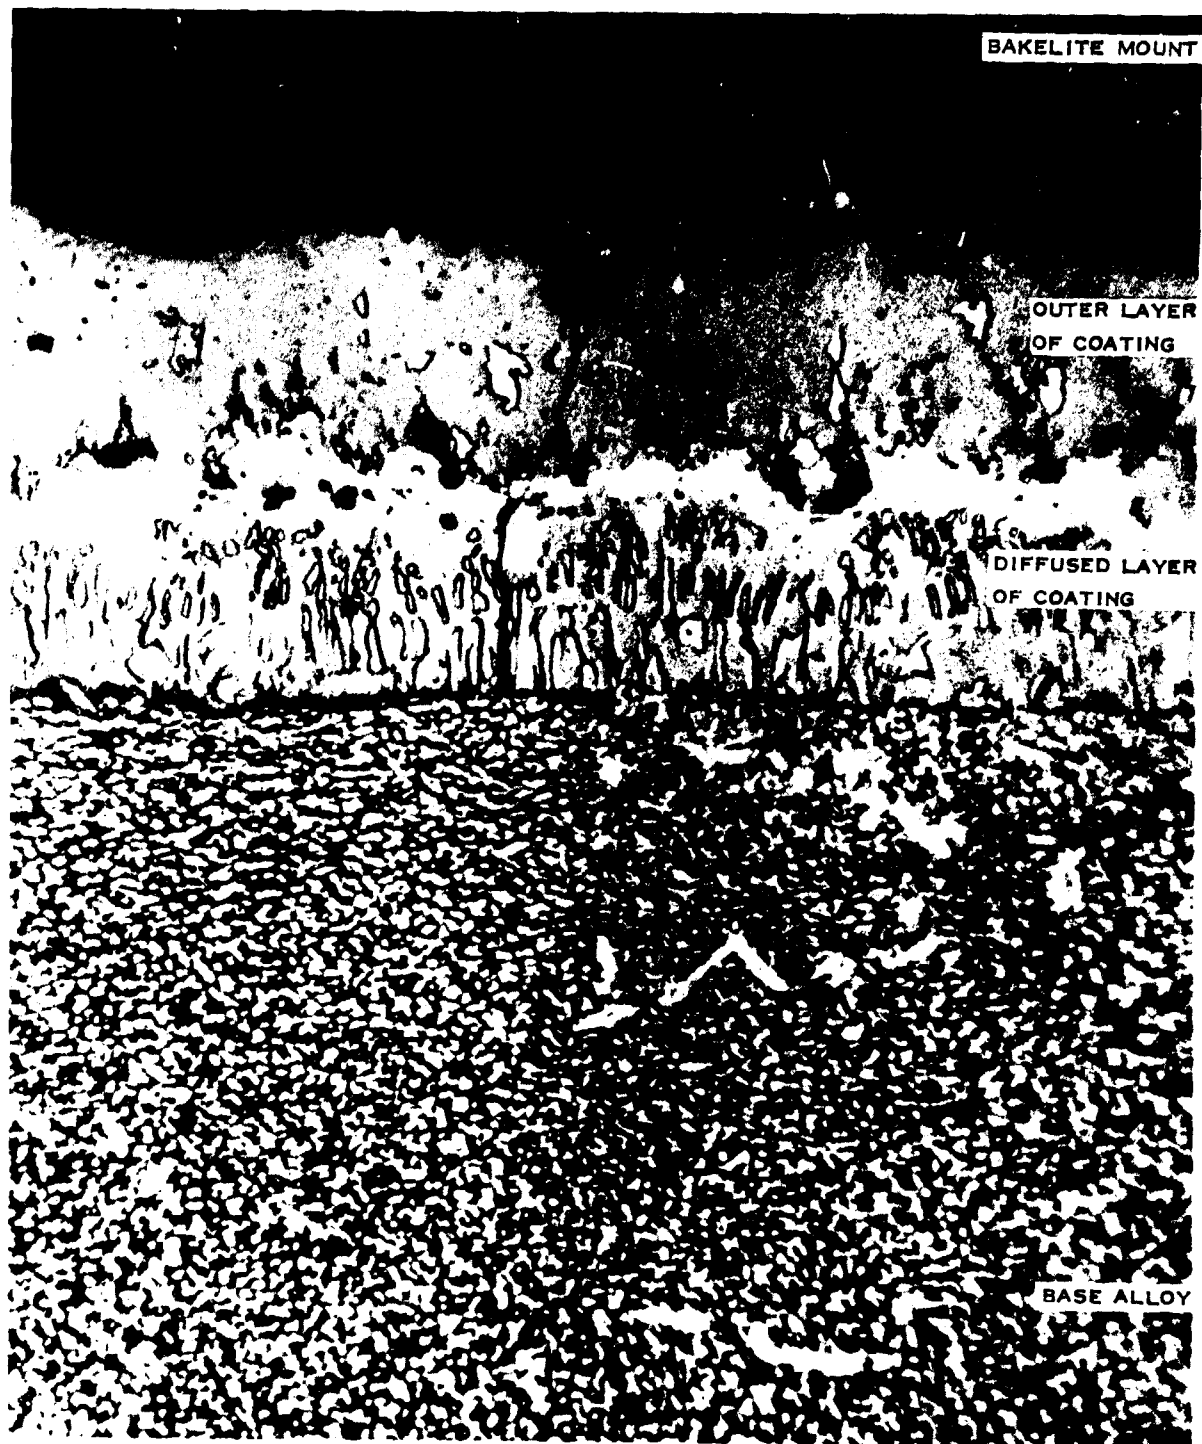
FIGURE 15
UNEXPOSED MISCO MDC-9 COATED INCONEL 713C SPECIMEN

Misco MDC-9 Coated Inconel 713C - A metallographic cross-section of a typical MDC-9 coated Inconel 713C specimen as received from Misco is shown in Figure 15. The aluminum-chromium type coating is about 2 mils thick and is divided about equally between an outer-layer and a diffused-layer.

METALLOGRAPHIC CROSS-SECTION, 3% SULFURIC ACID-ELECTROLYTIC ETCHED,
1000X MAGNIFICATION,

A metallographic cross-section of a typical MDC-9 coated Inconel 713C specimen as received from Misco is shown in Figure 15, and the coating is described in Section 4.1.2.

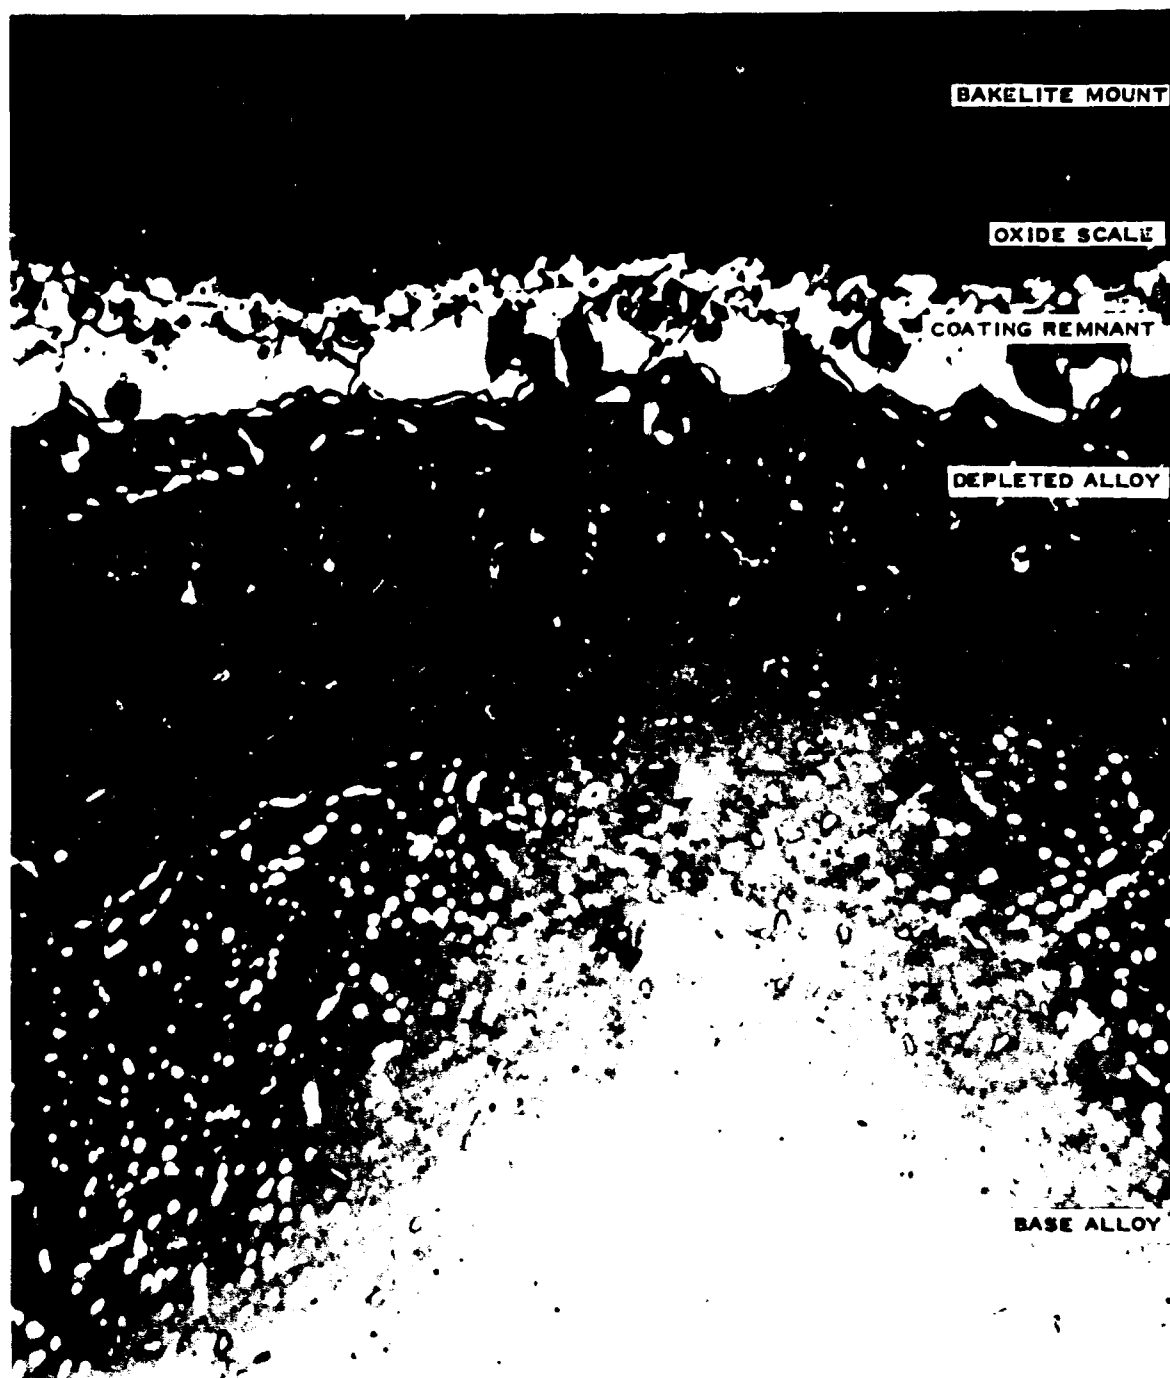
FIGURE 16
DEPLETION OF MISCO MDC-9 COATED INCCNEL 713C SPECIMEN

METALLOGRAPHIC CROSS-SECTION OF SPECIMEN AFTER 25 HOURS AT 2000 F TEST
CONDITION WITH 1.0 PPM SEA SALT IN AIR AND 0.040 WT % SULFUR IN FUEL.
2% CHROMIC ACID-ELECTROLYTIC ETCHED. 400X MAGNIFICATION.

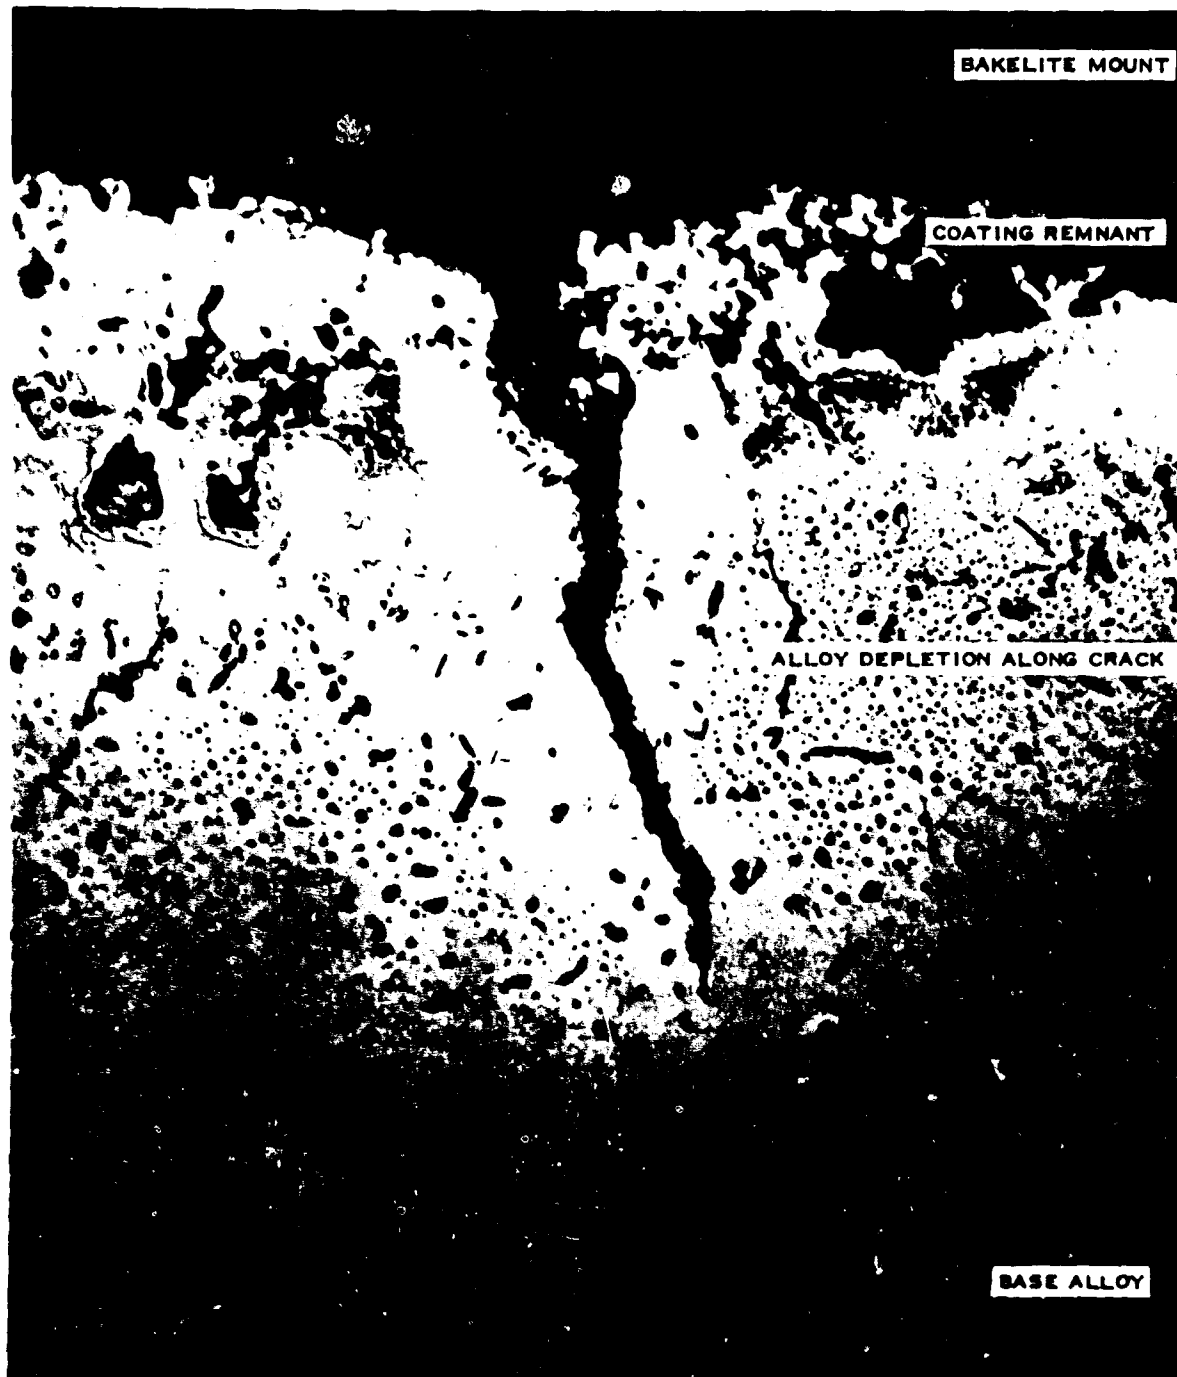
FIGURE 17
CRACK IN MISCO MDC-9 COATED INCONEL 713C SPECIMEN

METALLOGRAPHIC CROSS-SECTION OF SPECIMEN AFTER 25 HOURS AT 2000 F TEST
CONDITION WITH 1.0 PPM SEA SALT IN AIR AND 0.040 WT % SULFUR IN FUEL.
3% SULFURIC ACID-ELECTROLYTIC ETCHED. 400X MAGNIFICATION.

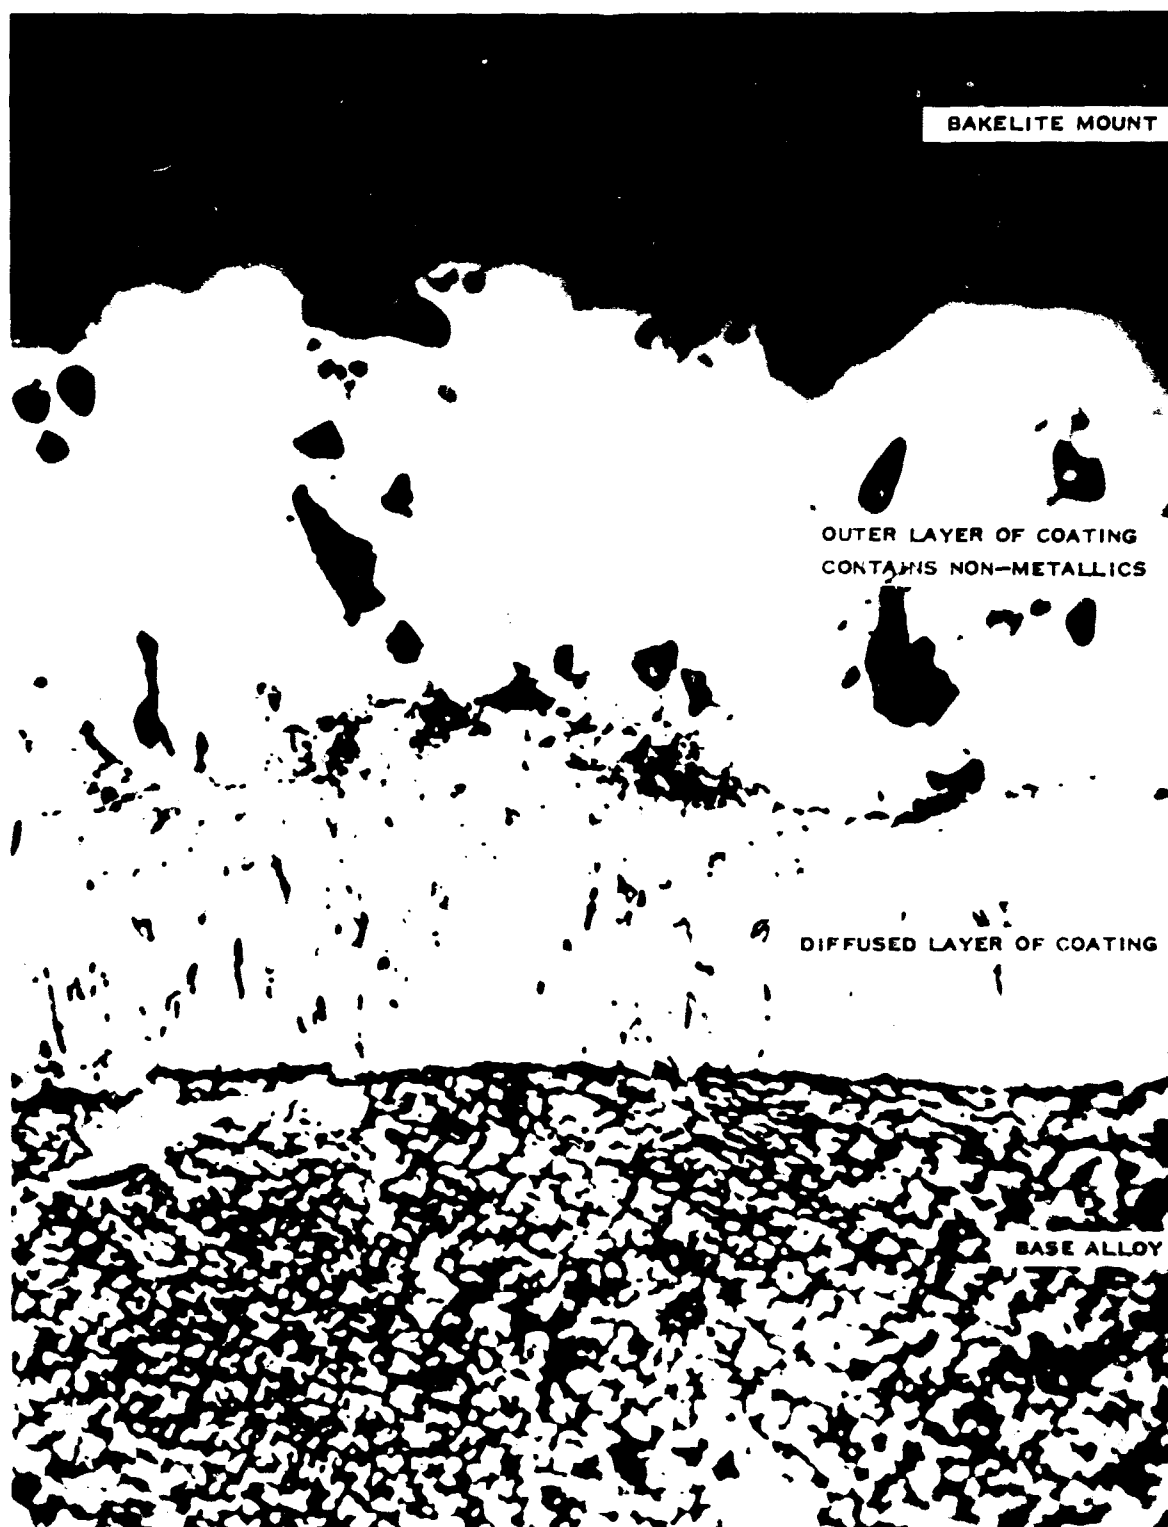
FIGURE 18
UNEXPOSED MISCO MDC-1 COATED MAR M-200 SPECIMEN

METALLOGRAPHIC CROSS-SECTION. 3% SULFURIC ACID-ELECTROLYTIC ETCHED.
2000X MAGNIFICATION.

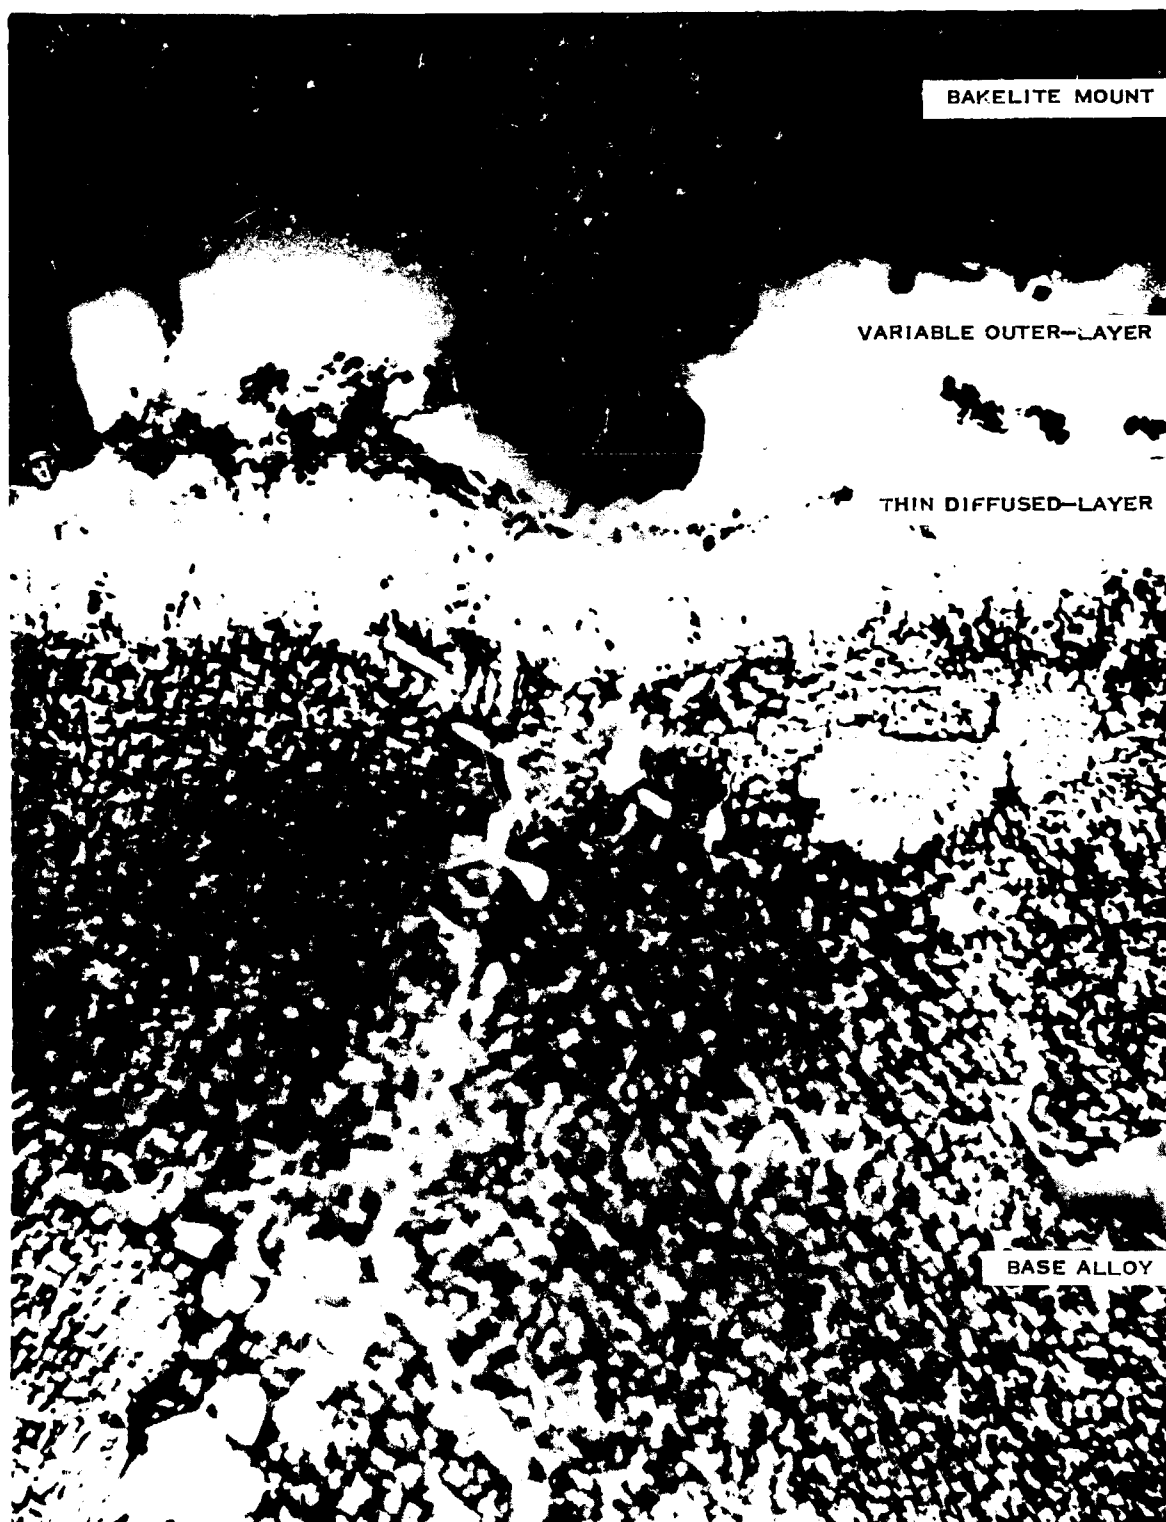
FIGURE 19
DEFECTIVE MISCO MDC-1 COATING ON MAR M-200 SPECIMEN

METALLOGRAPHIC CROSS-SECTION OF UNEXPOSED SPECIMEN,
3% SULFURIC ACID-ELECTROLYTIC ETCHED, 2000X MAGNIFICATION.
